Cycle Enfield – A1010 South Corridor

Stage 1 Road Safety Audit

Ref: 2643/032/A1010/BOR/2016

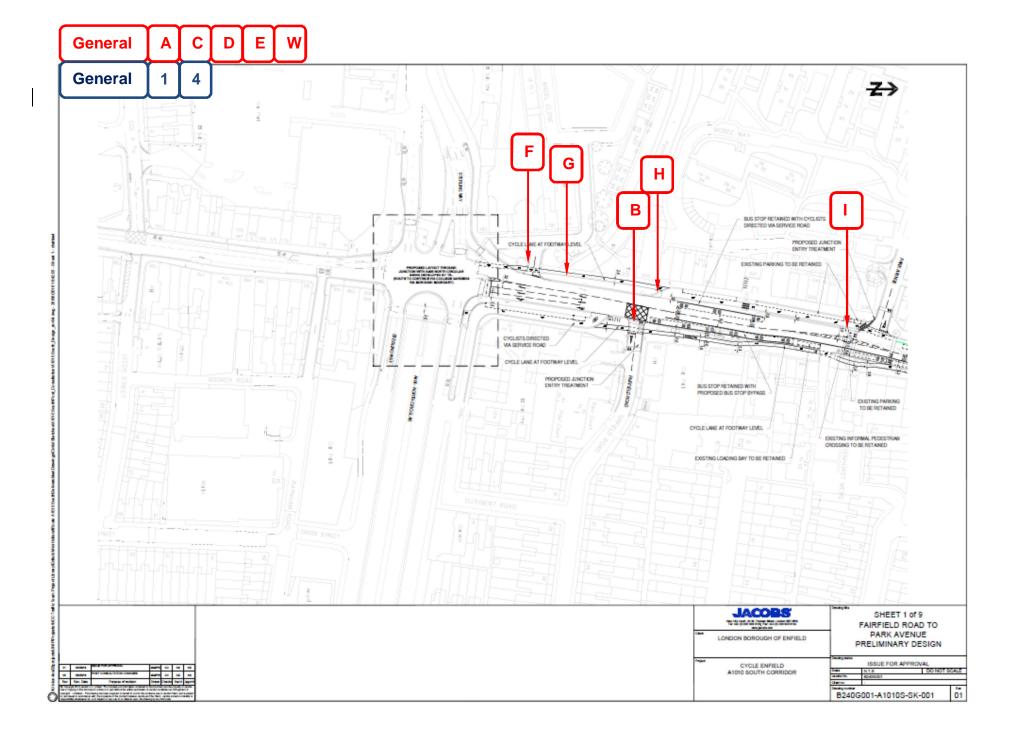
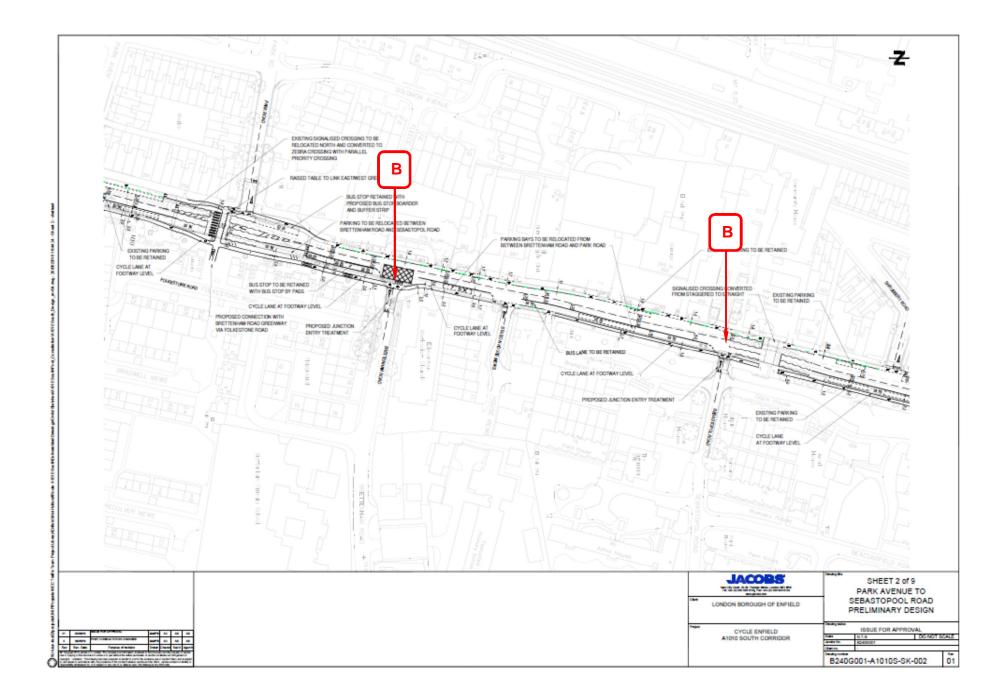
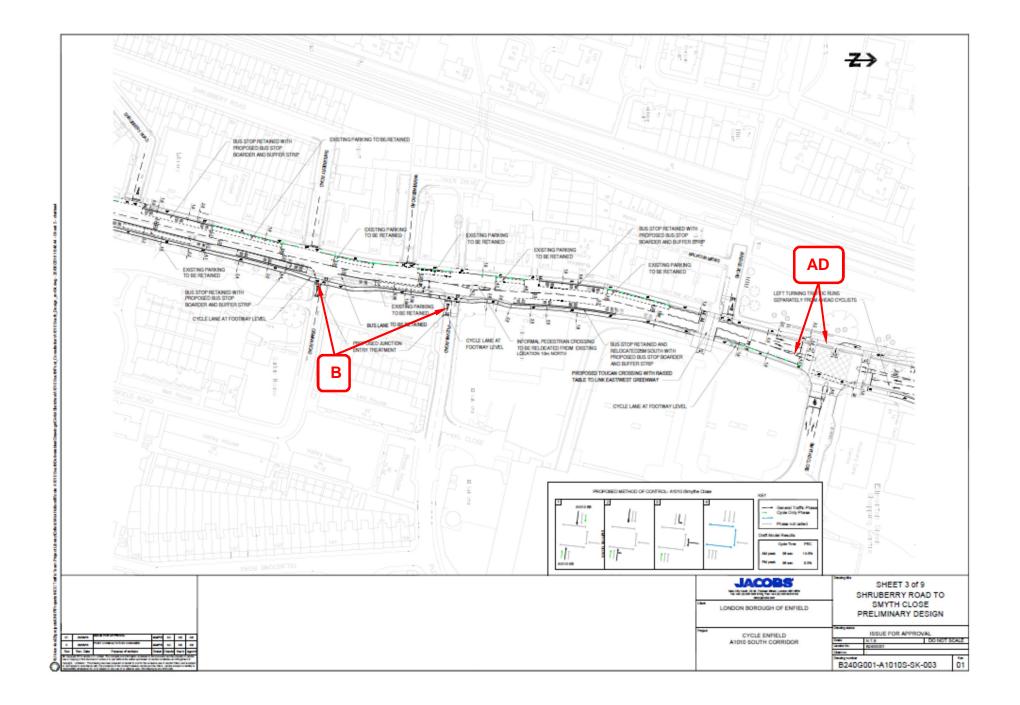
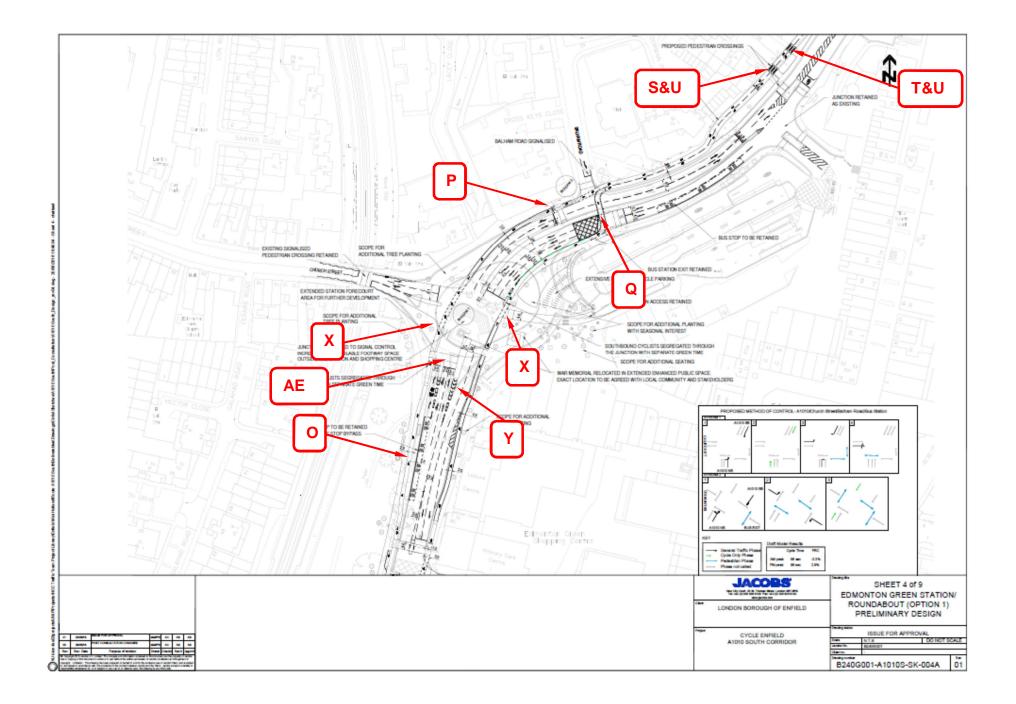
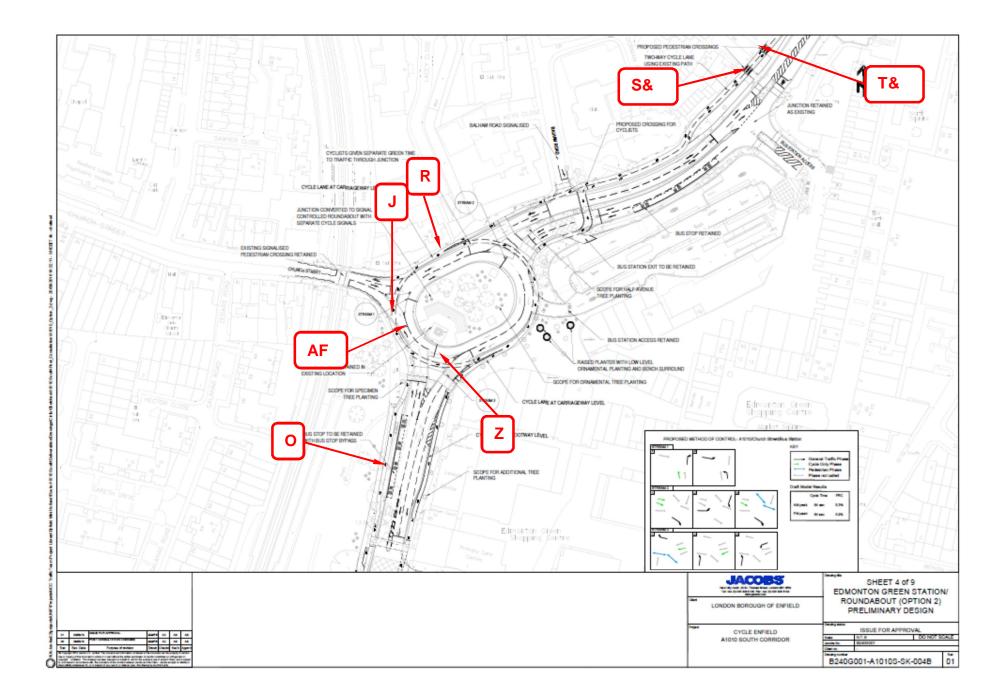
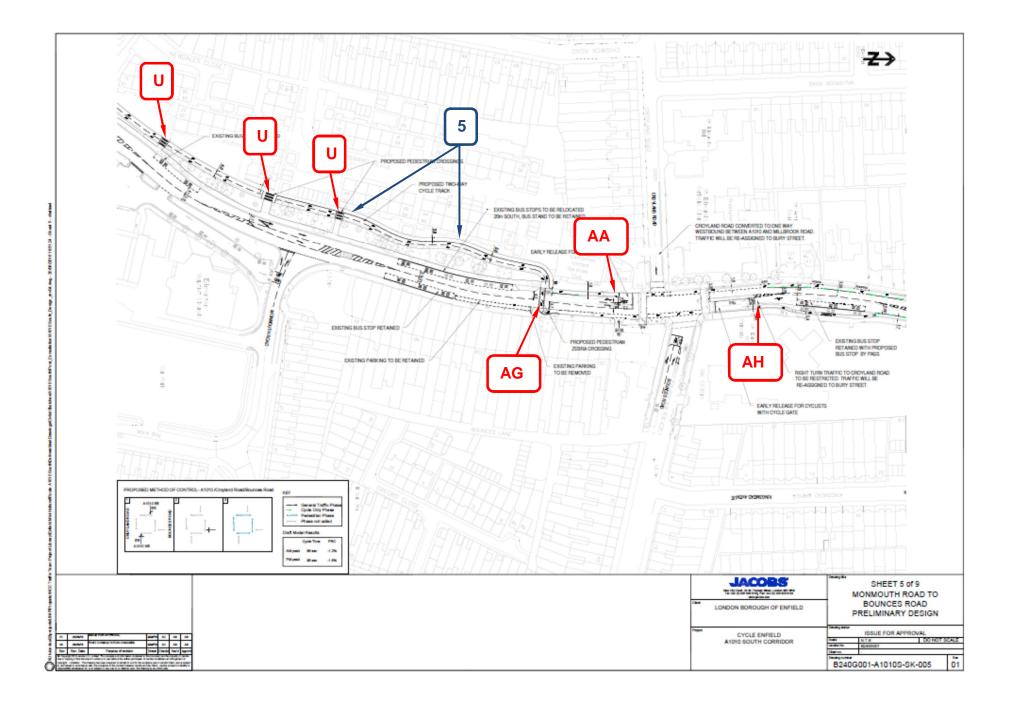
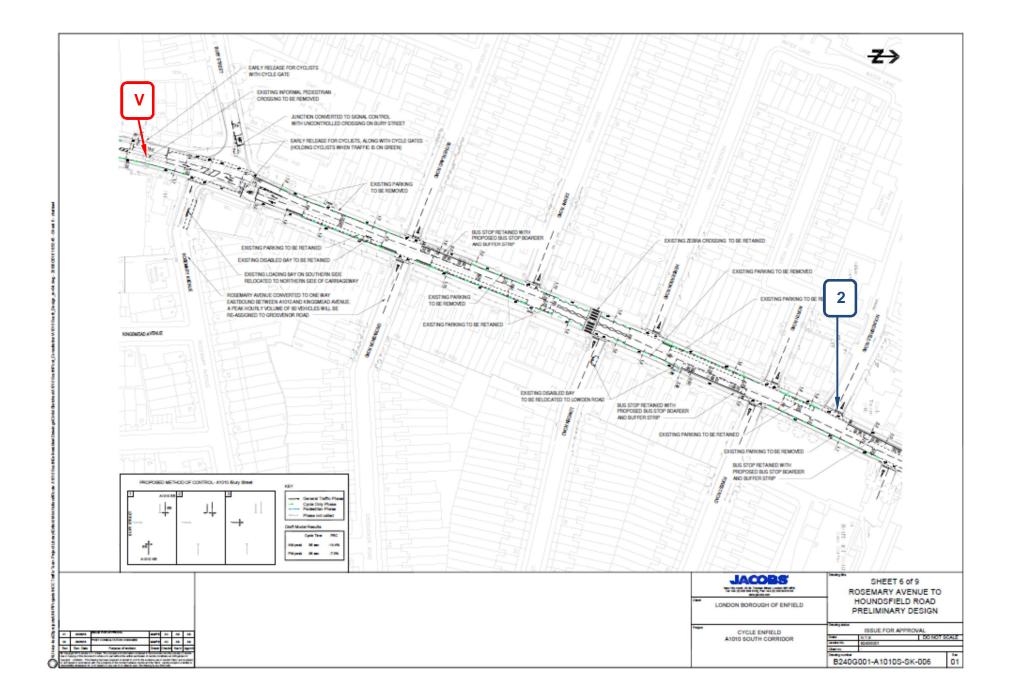
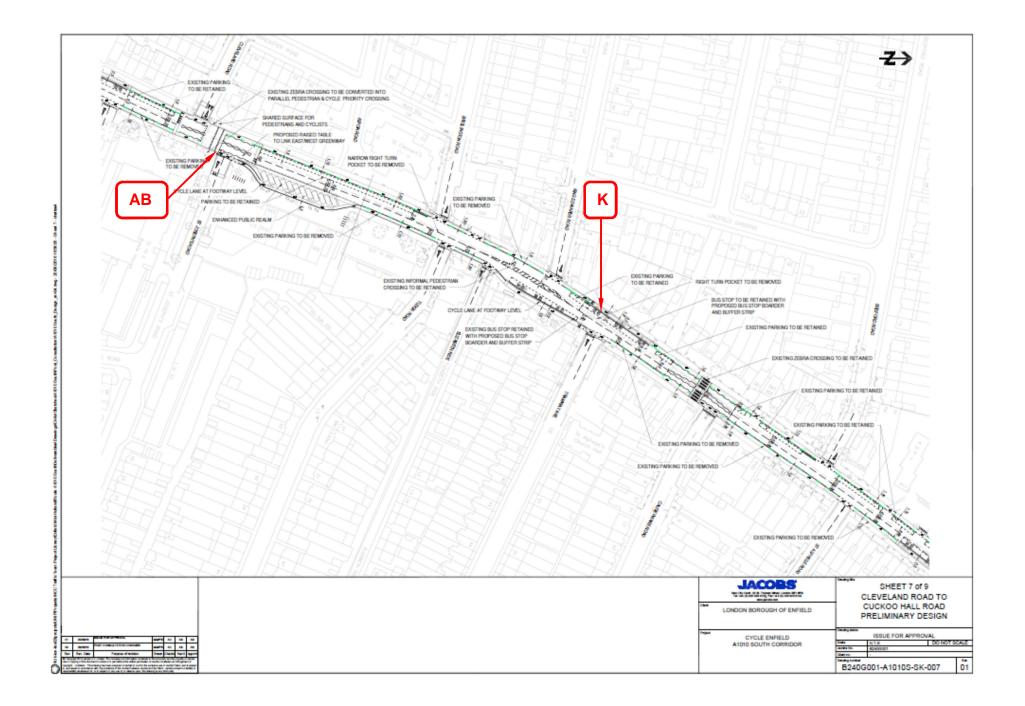
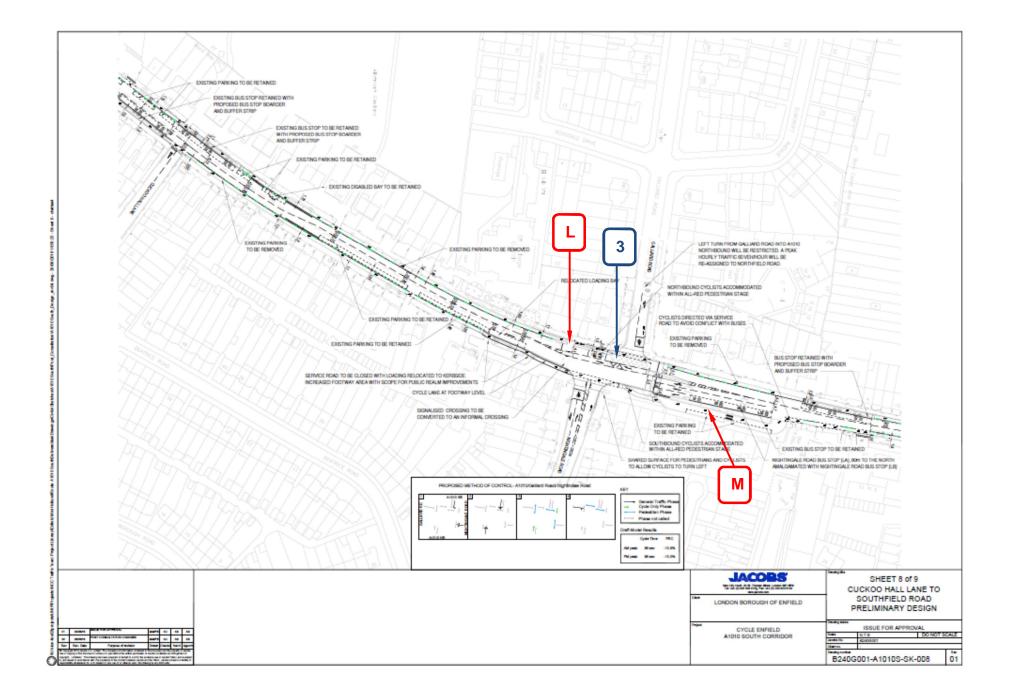
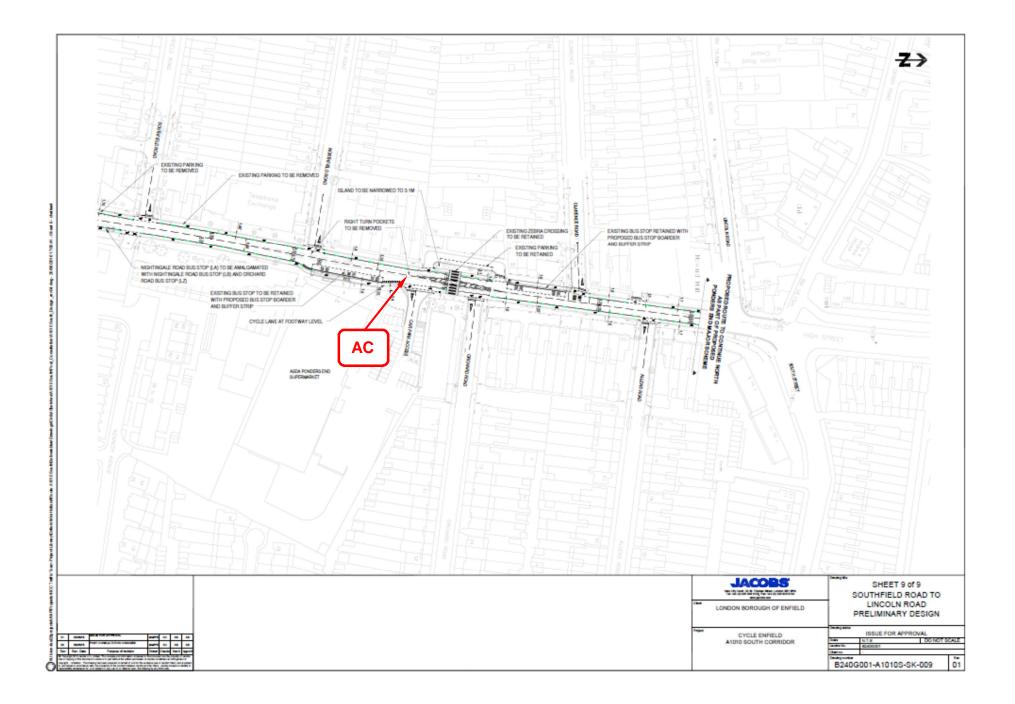
Problem Locations

APPENDIX B

- 1.2.5 Unless general to the scheme, all comments and recommendations are referenced to the detailed design drawings and the locations have been indicated on the plan located in Appendix B.
